REGIONAL SCHOOL DISTRICT 18

Facility Study – Mile Creek

August 15, 2021

Existing Conditions Survey

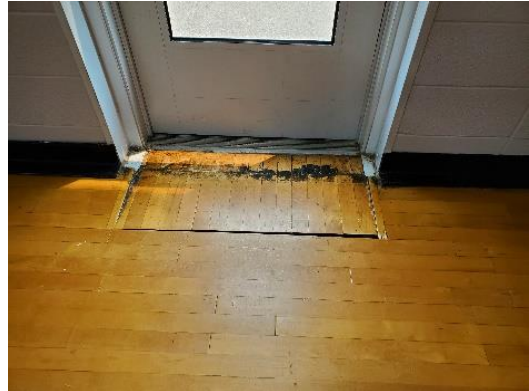
- **Wood Floors:** The gymnasium floor is a typical wood floating floor system. There are areas in the floor that are starting to show excessive wear including the custom transitions made to get down to the exterior door elevations.
- **Entrance Mat Systems:** As per the Connecticut high performance building standards, 3-part entrance mat systems are required to minimize particulars and maintain indoor air quality. Mile Creek uses a mix of walk off carpet tile as well as portable surface mats. While some are doubled up, a permanent full walk off system is suggested, and replacement of the deteriorated entrance walk off system.

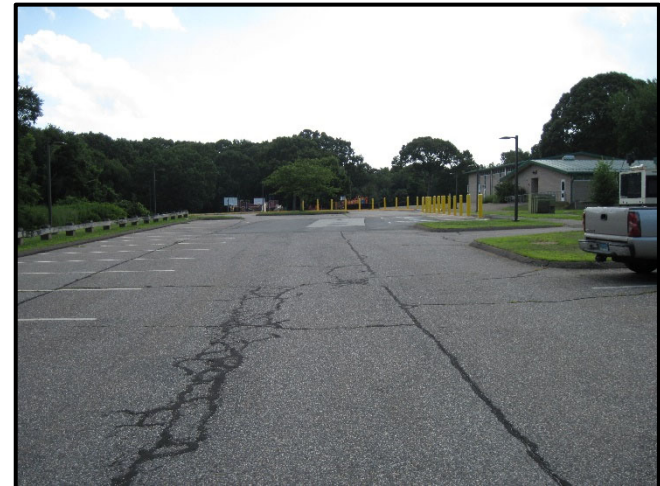
Lot 3 looking south. Sealed longitudinal cracks and fatigue cracks visible.

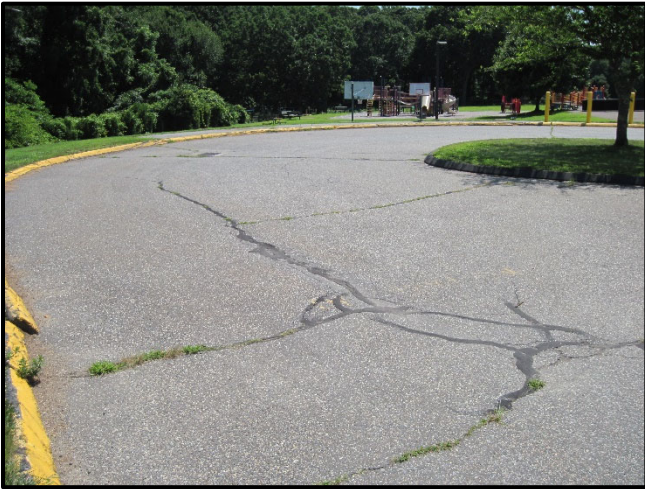
Sealed cracks and localized fatigue cracks visible.

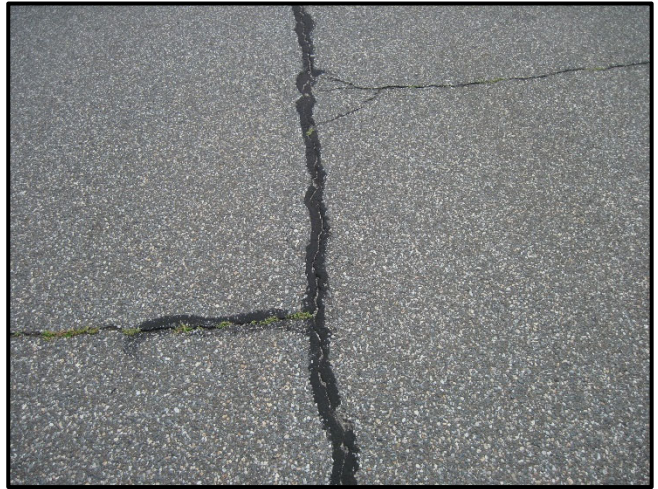
Typical failure of crack sealant. Additional crack propagation visible.

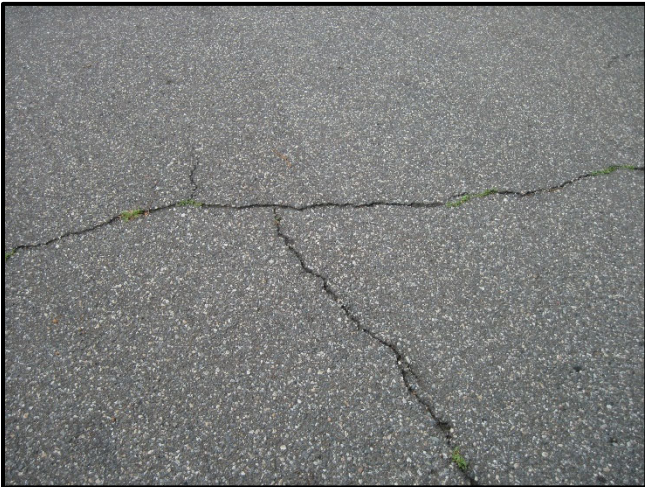
Unsealed pavement shrinkage cracks.

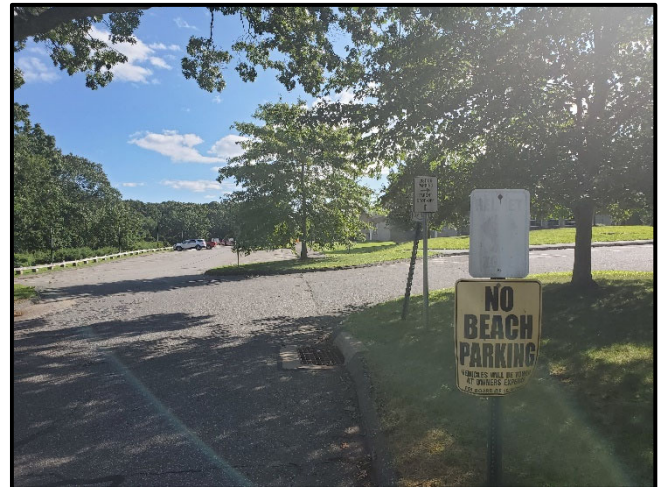
Sign clutter at Drive 2.

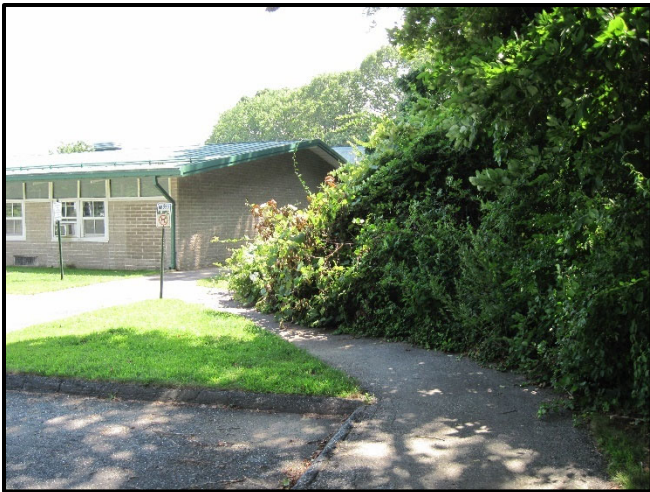
Bituminous sidewalk on west of side Lot 1. Vegetation should be cleared from walking areas.

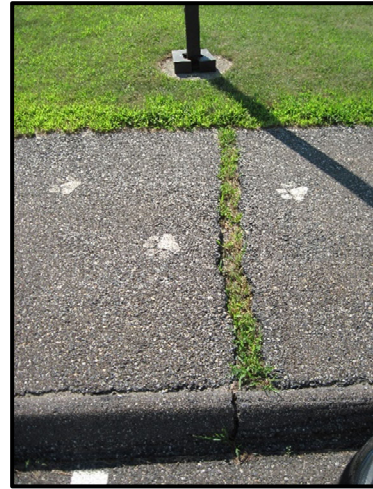
Shrinkage crack in bituminous walkway (at Lot 3).

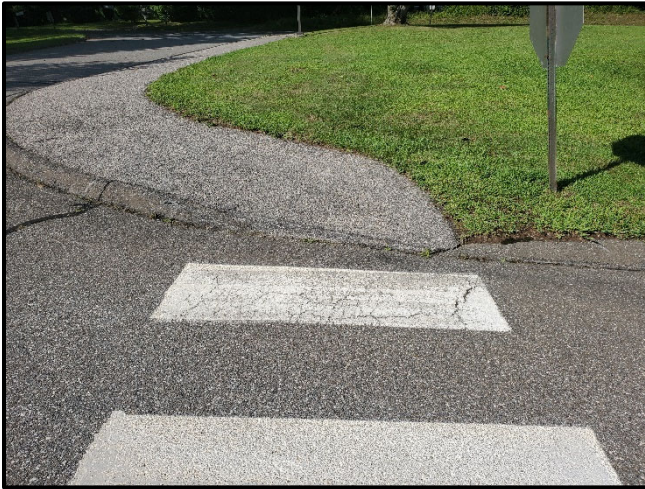
North curb ramp on east side of Drive 1 at Lot 2 crossing. Ramp is not in compliance with ICC A117.1, 406.

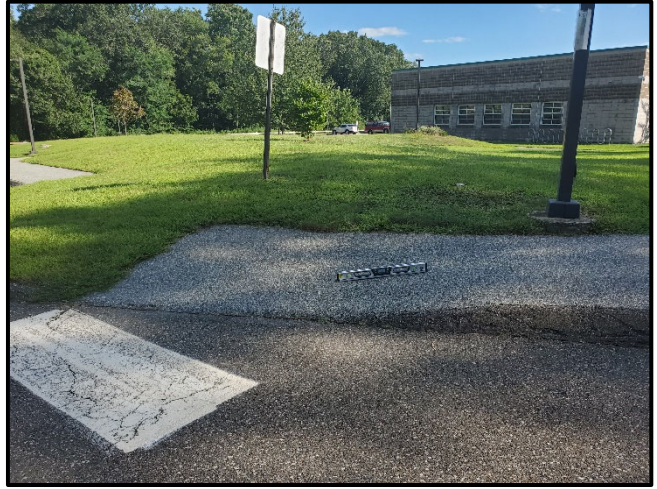
South curb ramp on east side of Drive 1 at Lot 2 crossing. Ramp is not in compliance with ICC A117.1, 406.

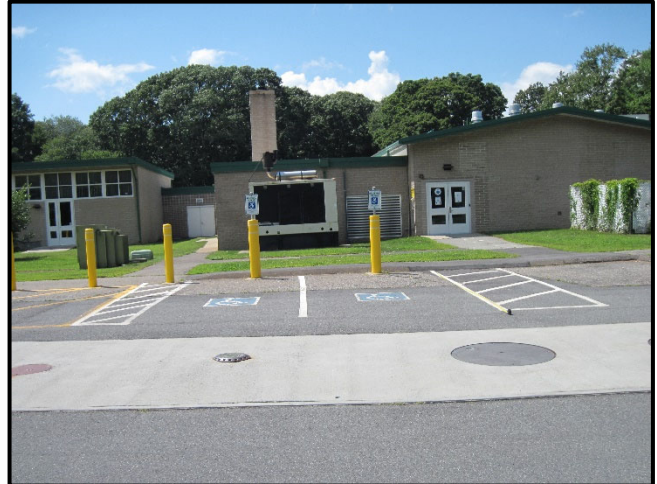
Existing accessible parking sign at Lot 3 (2 spaces). Right (north) access aisle not connected to "Accessible Route".

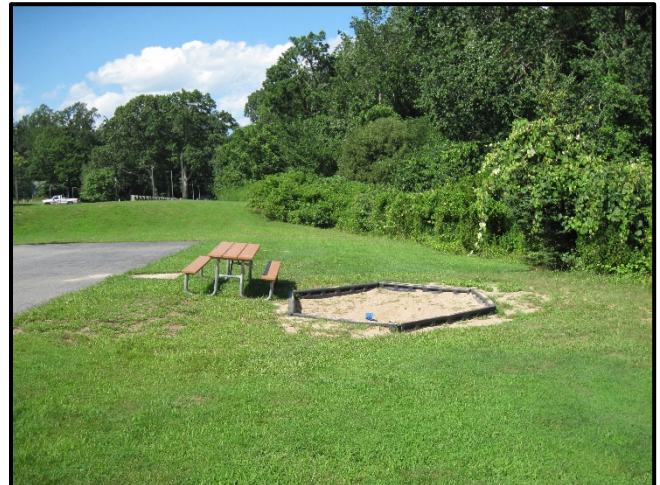
Sandbox adjacent to Court 1, looking north. Sandbox cover recommended.

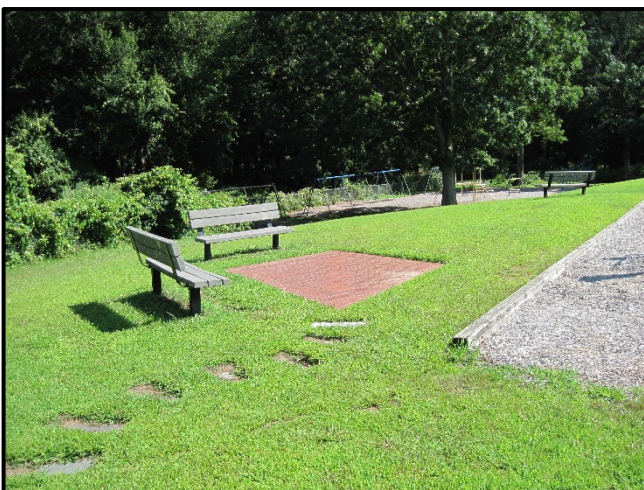
Seating area east of Play Area 3. No accessibility to this location.

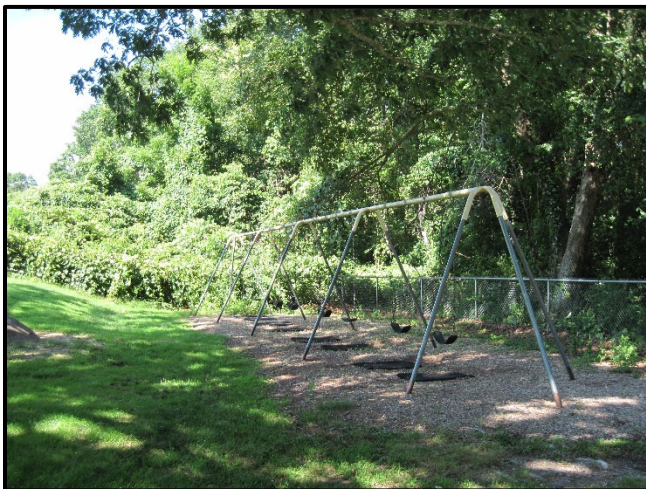
Swing set 1 of 3 in Play Area 4, looking north. Proximity of wood line and overhanging branches visible.

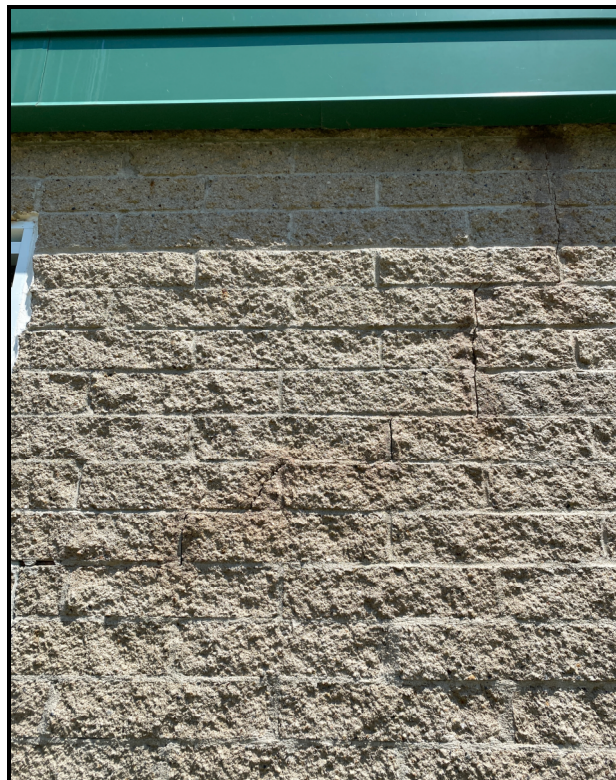
PHOTO 2: 7/23/2021 – Boiler Room – Mortar Crack

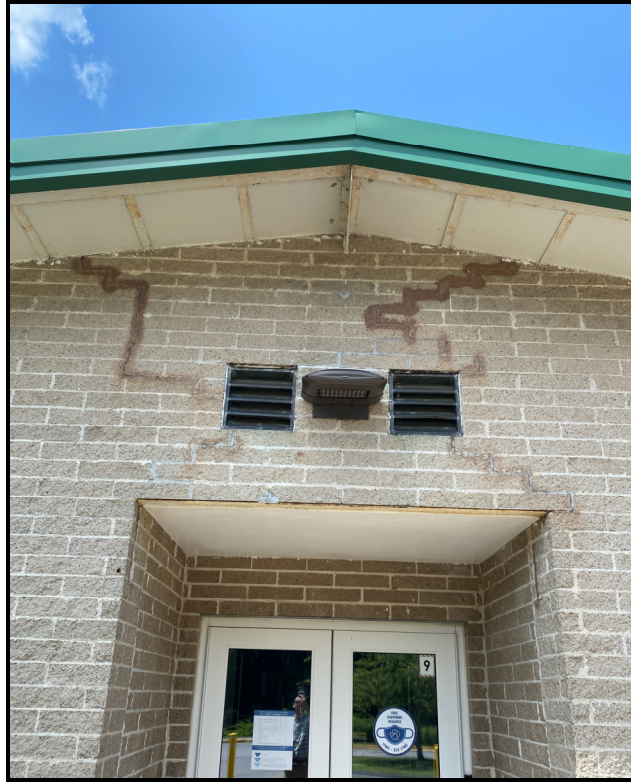
PHOTO 3: 7/23/2021 – Mortar Cracks at Vestibule 1121

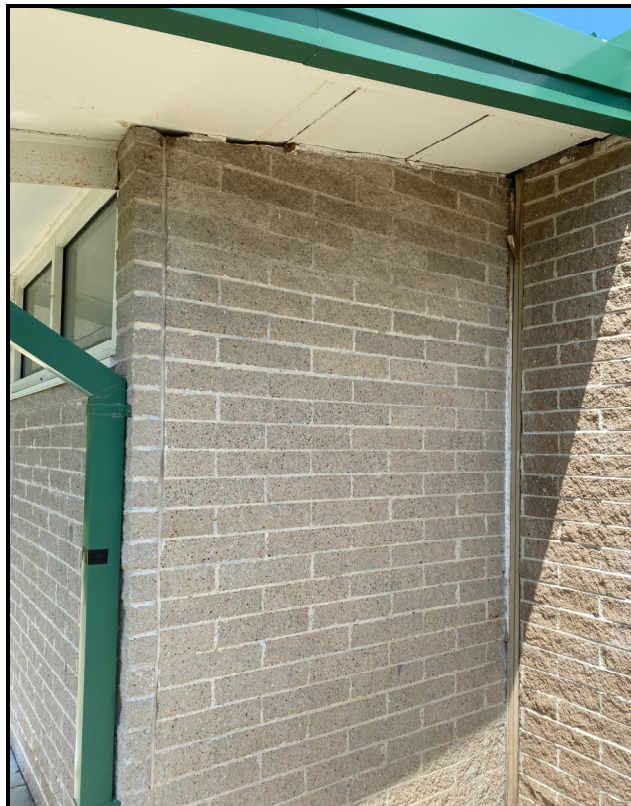
PHOTO 4: 7/23/2021 – Deteriorated caulking and rusted structural steel at soffit

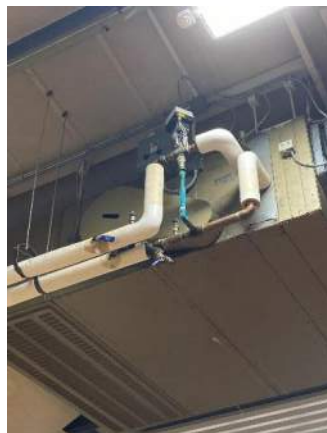
Gym AHU

- b. The gymnasium is ventilated and heated through two indoor air handling units which appear to be greater than 30 years old and beyond their useful life. The units show

some signs of minor corrosion on the connected piping. Newer units could provide variable speed control and enhanced efficiency for an energy savings.

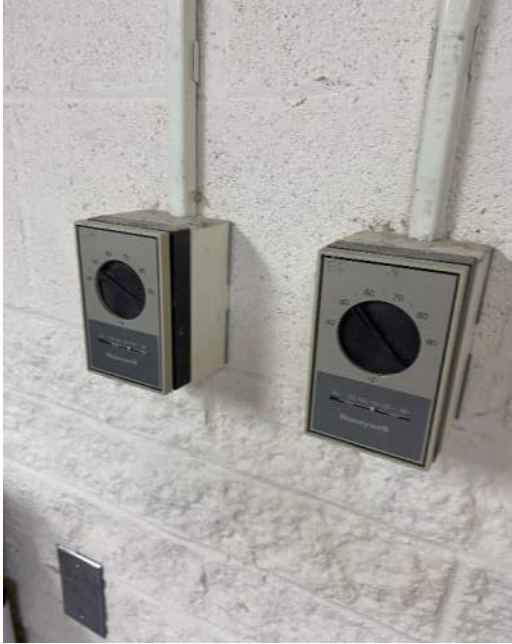
Analog controls

1. Controls were observed to generally be a mix of ages from the previous renovation 20 years ago as well as prior to that time. This included Direct Digital Control (DDC) capabilities for some equipment and analog controls for other equipment. Controls hardware, devices, and wiring generally have a 20-30 year useful life which much of this system is equal to or older than. Any future renovations should include replacement of controls hardware and upgrade to a newer DDC platform. Existing systems can be integrated into the new platform if partial renovations occur. The condition of controls within this building is worse than other sites in the Town.
