REGIONAL SCHOOL DISTRICT 18

Facility Study – Mile Creek

August 15, 2021

Existing Conditions Survey

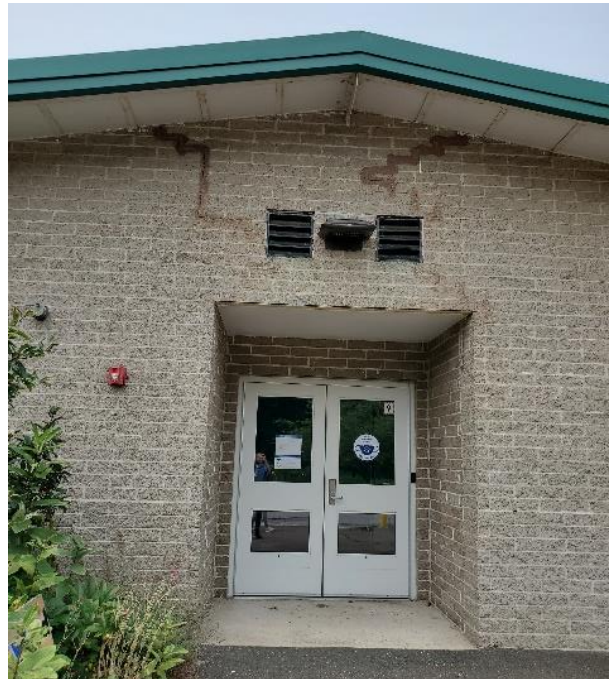
Masonry: The primary exterior wall assembly is consistent throughout the building. The exterior walls are typically a masonry wall with CMU or metal stud backup and a CMU veneer. The CMU has been maintained over the years however there are several areas where there are noticeable cracks and repair due to a lack of control joints in the veneer. There is notable staining from metal pieces and infilled openings from past renovations.

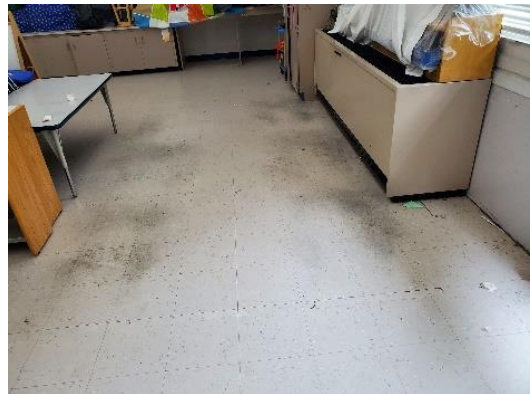
- *Vinyl Tile:* Much of the school is vinyl tile that appears to be in good to fair condition. Many of the tiles have been maintained with minimal cracking or damage noted. There are certain rooms and spaces that show heavier wear and damage then other and would benefit from replacement.
- *Ceramic Tile:* In lavatories, the ceramic tile floors also appear to be in good condition with no noticeable cracked or broken areas. Grout damage or discoloration was minimal and consistent with the age of the tile.

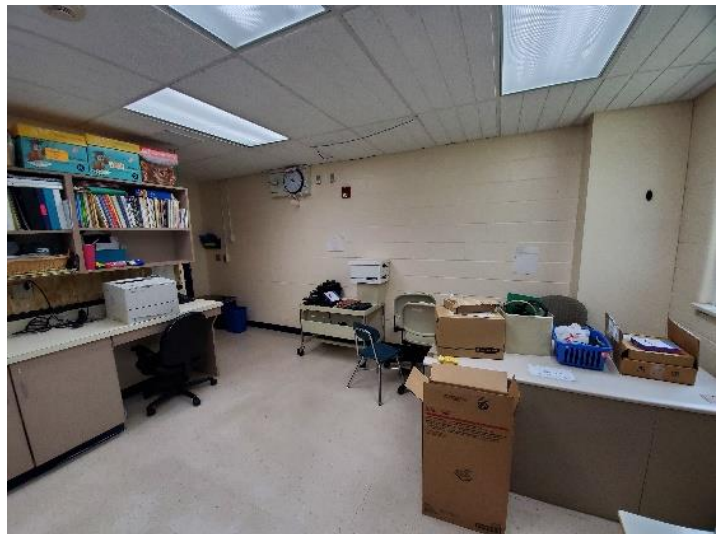
Ceiling Systems: Ceiling products age more quickly than others and require consistent replacement. Often these systems are replaced completely with lighting upgrades or mechanical installations. The ceilings at Mile Creek seem to generally be in good condition however are varied throughout the school. As expected, there are some areas where the ceiling should be replaced such as stained and damaged tiles in portions of the classrooms, and corridors; this most likely has been caused by ongoing maintenance or IT work in the school. There also seem to be more dated ceiling tiles in certain spaces that might benefit from the new acoustic properties provided by the newer tile designs.

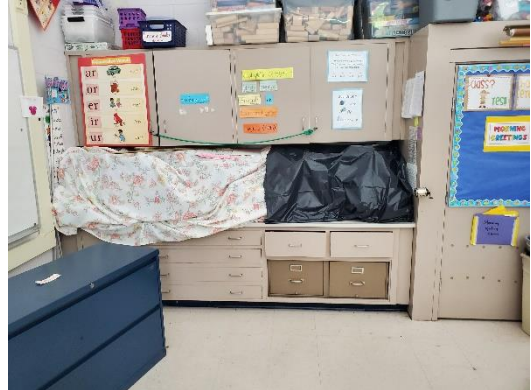
The condition of the existing cabinets and millwork in the building appears to be in fair to poor condition. They have been maintained well over the years but are quite old at this point and

have several layers of repairs done to them. The design of the casework is also dated and does not function properly with today's curriculum and classroom setups. Many rooms have broken and not used recessed filing cabinets. Storage areas are not equipped with interior storage solutions and drawers do not have standard roller hardware.

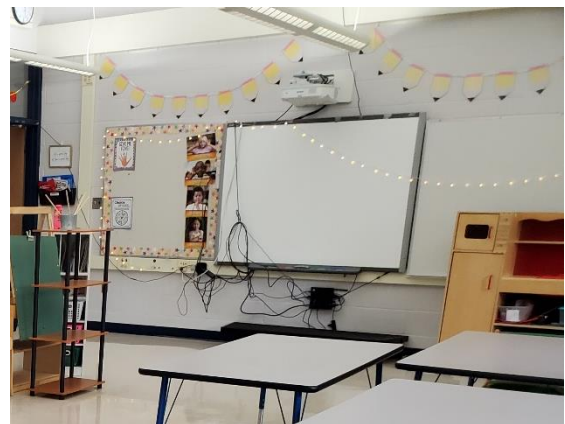
Visual Display Surfaces: The district maintenance and IT programs have updated the teaching walls in the classrooms to have smartboards and short throw projectors accessed by a desktop computer. As with all retrofits of a building this age, it is difficult to find a clean solution with power, data, and AV cables

Instructional Surfaces: Classrooms are equipped with at minimum one marker board and tack board system. Some classrooms have additional marker board spaces that are utilized as supplemental instructional spaces.

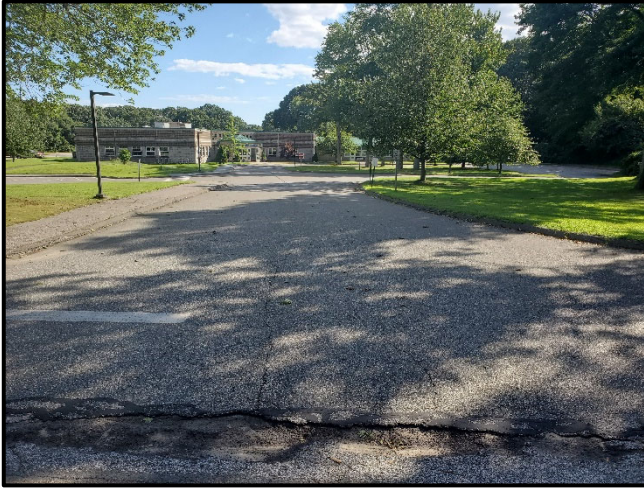
Drive 1 looking south from Mile Creek Road.

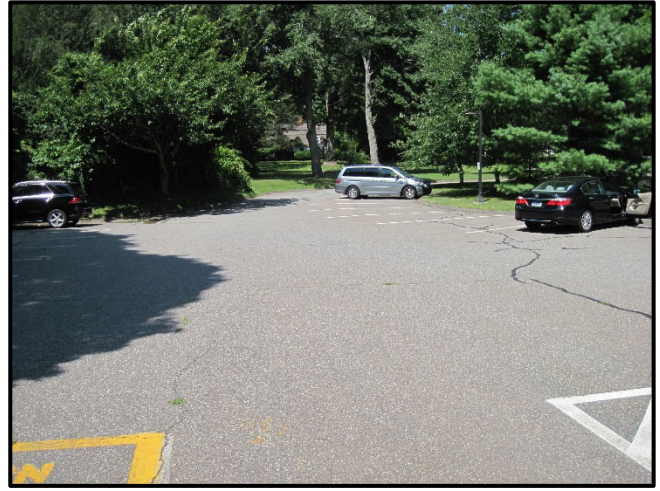
Drive 1/Lot 1 looking north from accessible parking spaces.

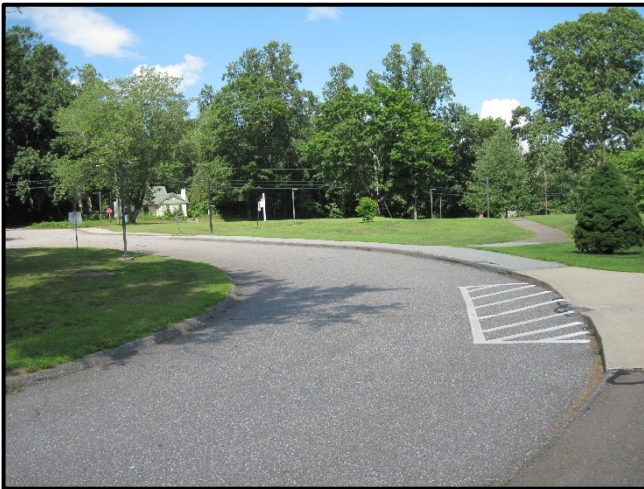
Drive 1 loop drive at front of school at main entrance.

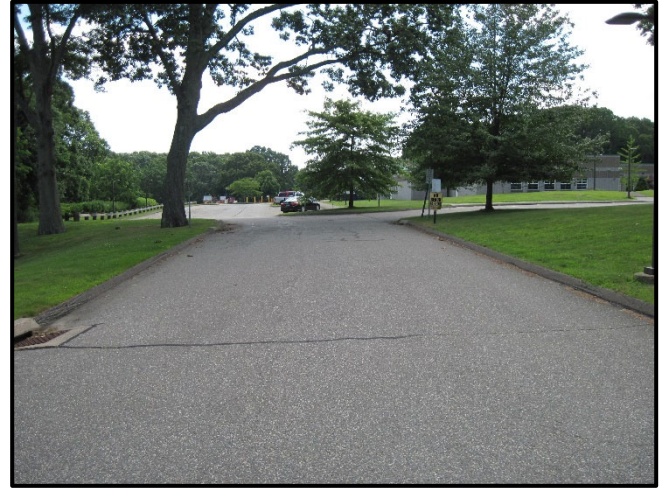
Drive 2 looking south from Mile Creek Road. Lot 3 visible in background.

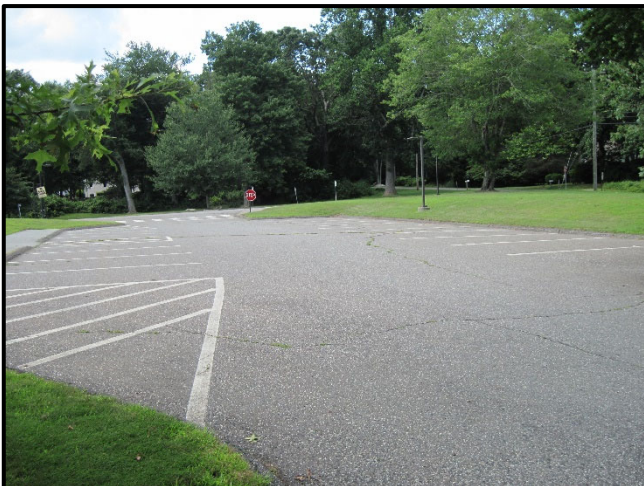
Lot 2 looking west.

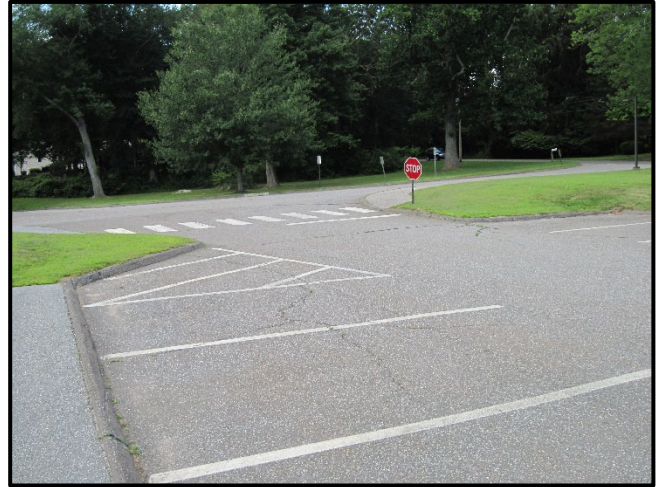
Typical pavement markings.

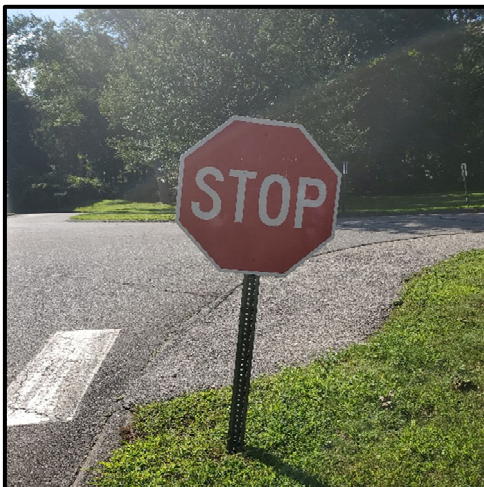
Typical site sign.

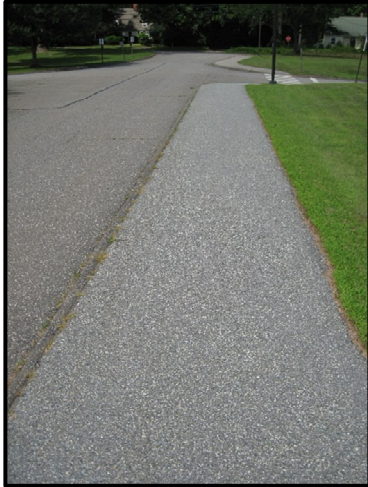
Bituminous sidewalk at Drive 1 looking north.

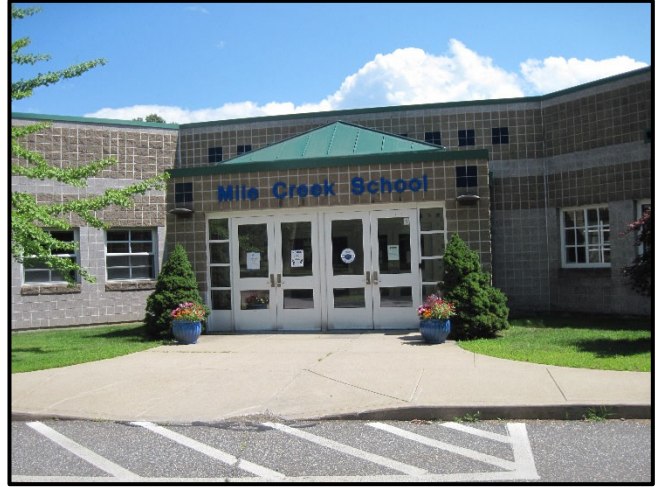
Concrete walkway area at main entrance.

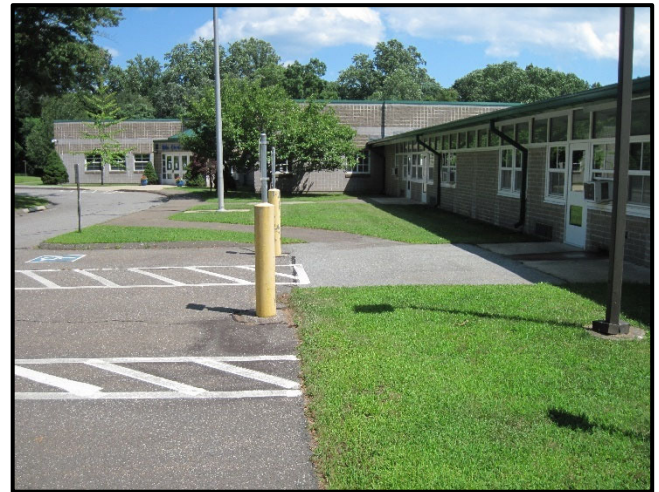
Bituminous site walkways at front of school looking north.

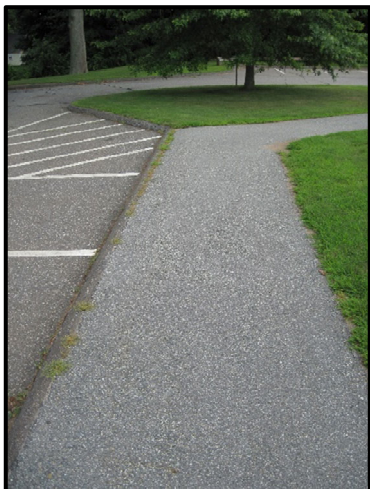
Sidewalk along south side of Lot 2. south.

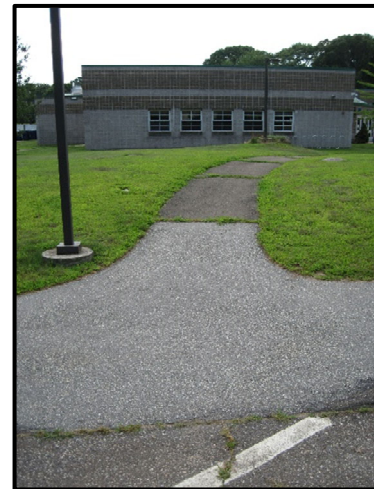
Walkway adjacent to Lot 2 providing access to Main Entrance (looking south).

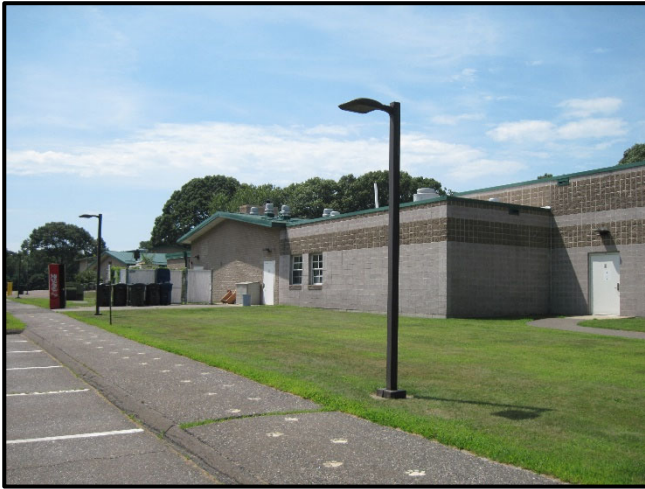
Sidewalk along west side of Lot 3, looking south.

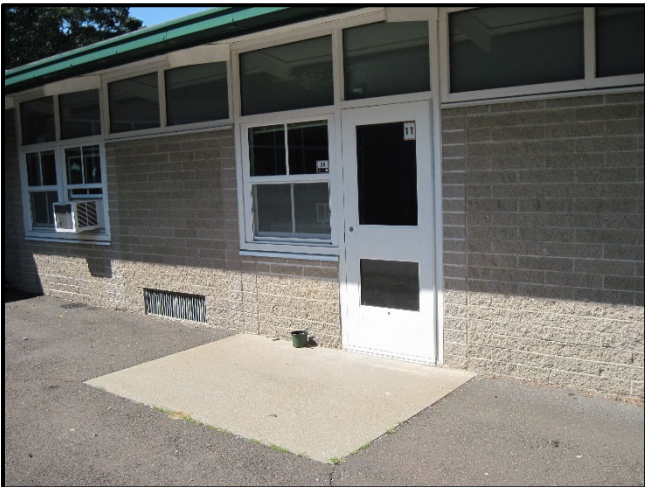
Typical paved area adjacent to building.

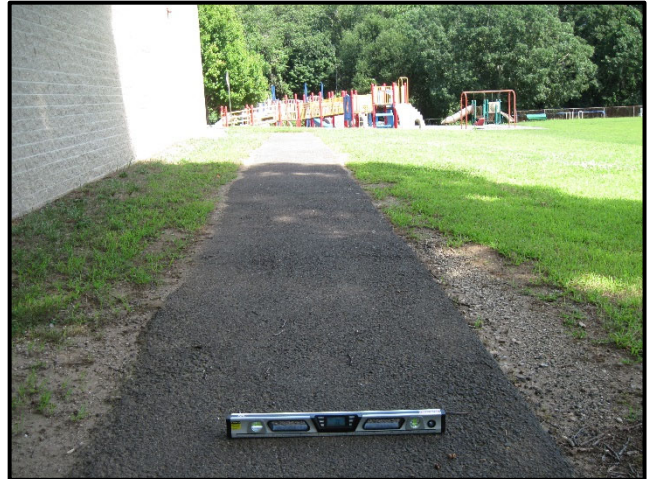
Bituminous walkway at far south end of building, looking east. Athletic fields to right of photo.

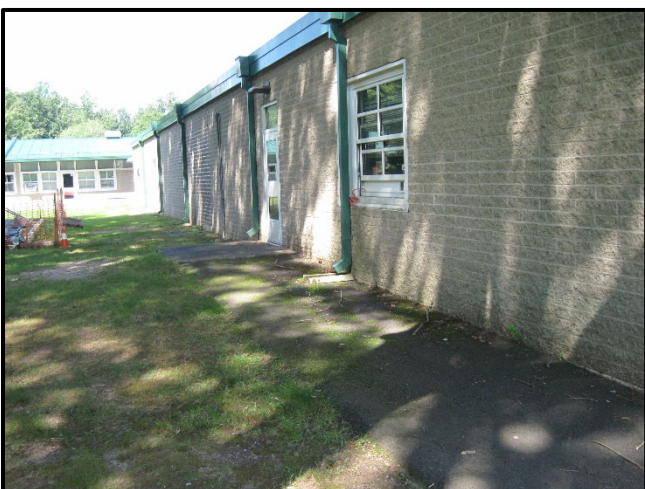
Bituminous walkway along west side of building serving Door 15.

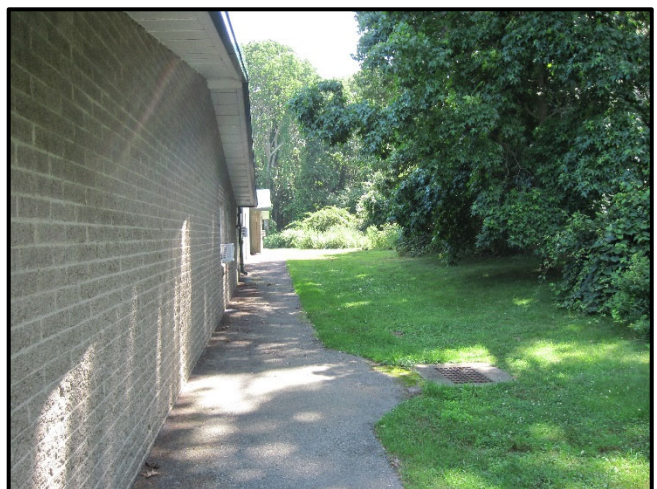
Bituminous walkway along west side of building.

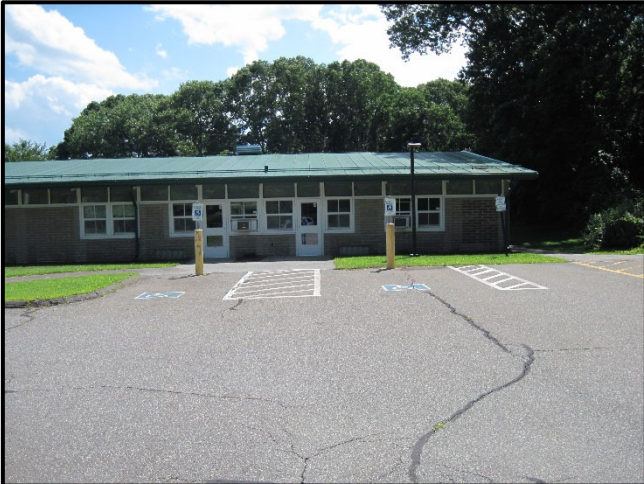
Existing accessible parking at Lot 1 (2 spaces). Right (west) access aisle not connected to "Accessible Route".

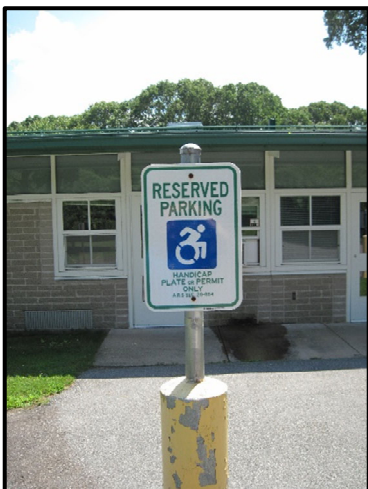
Existing accessible parking sign at Lot 1. Not compliant with CGS 14-253a subsection (h); CTBC Amd 1111.1

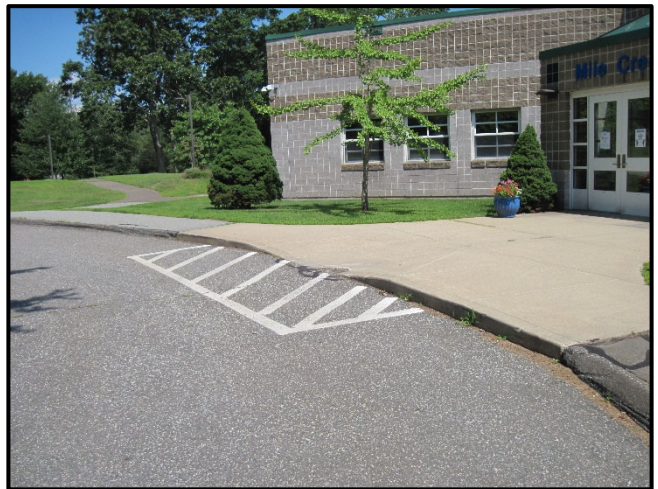
Passenger Loading Zone 1 (PL1) at main entrance to school (Door 1). See Passenger Loading Zone tables.

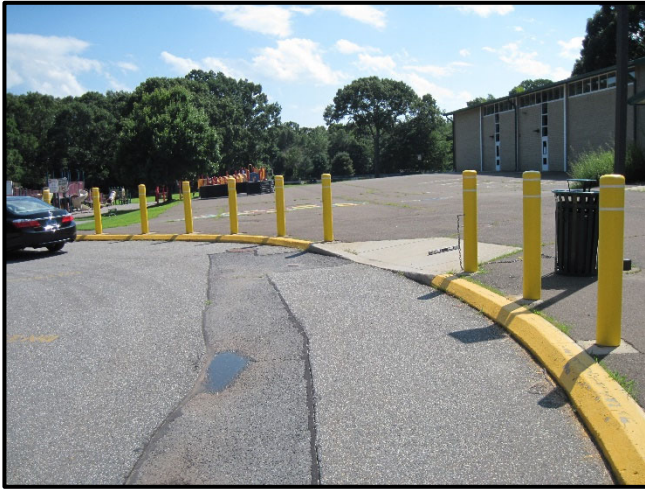
Passenger Loading Zone 2 (PL2), east side of school in Lot 3 drive loop. See Passenger Loading Zone tables.

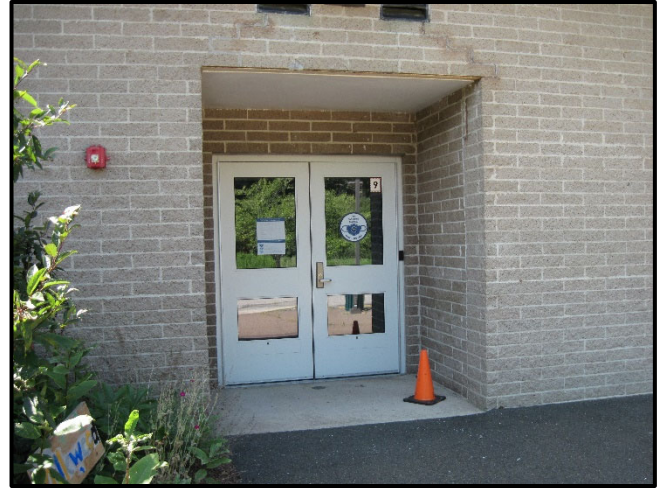
Typical accessible doorway, recessed, checked against ICC A 117.1 Chapter 4, 402 and 404.2.3.5.

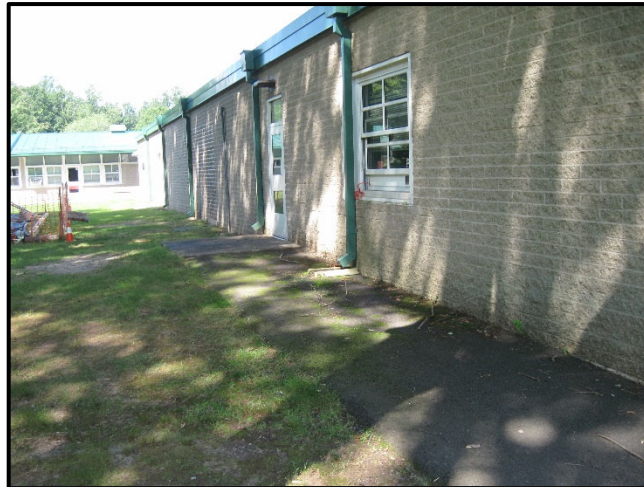
Looking north towards Door 15. Accessible means of egress must be compliant with IBC 1009.2, 1104, and ICC A117.1 Chapter 4, 402. Downspouts should be modified to eliminate discharge to walking surfaces.

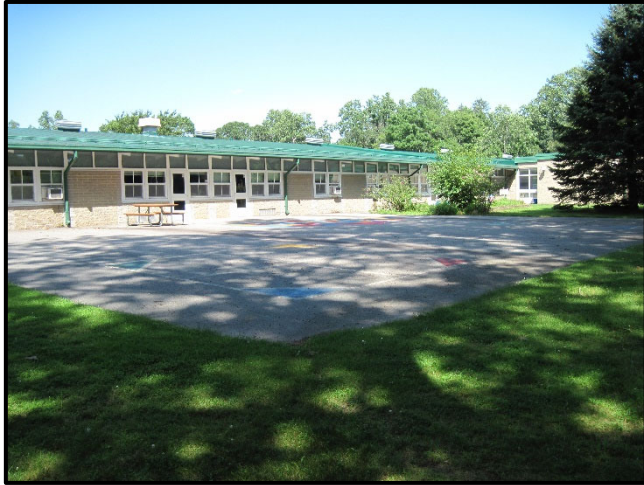
Play Area 1 looking northeast. Bituminous concrete, multi-use play area.

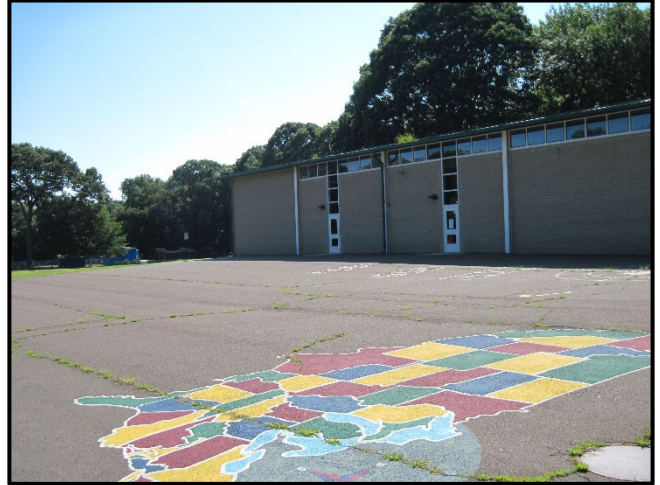
Play Area 2 looking southwest. Bituminous concrete Multi-use play area. Doors 13 and 14 in background.

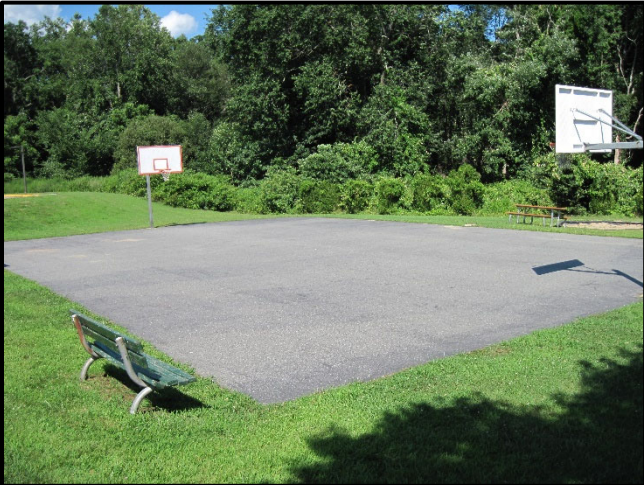
Basketball Court (Court 1) looking northeast.

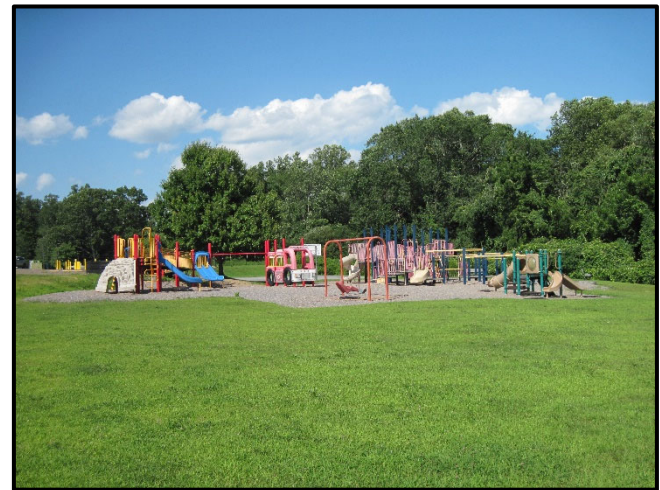
Play Area 3 looking northeast.

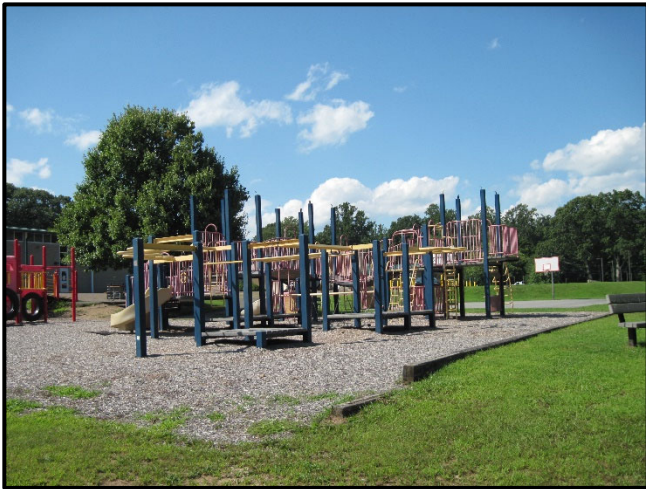
Typical play equipment in Play Area 3 looking north.

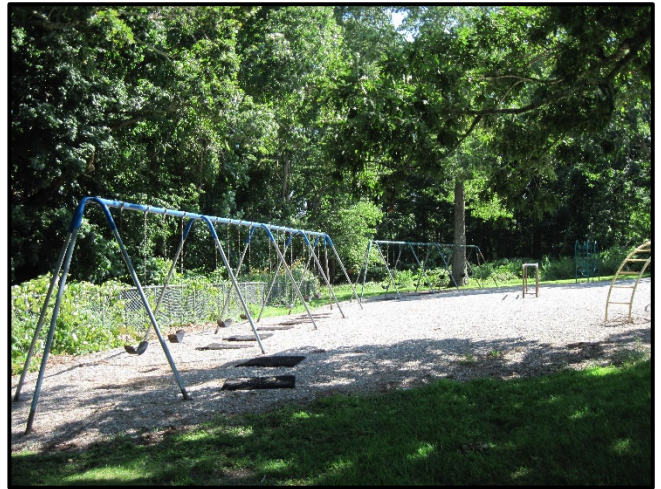
Play Area 4, looking south.

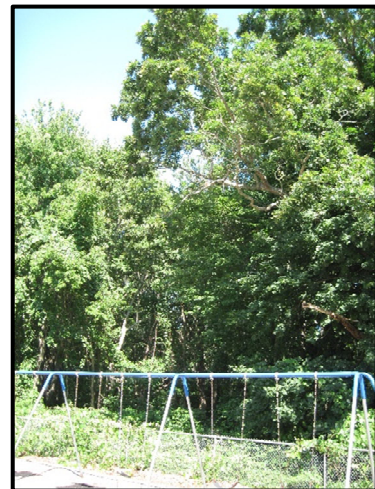
Dead branches near swing set in Play Area 4.

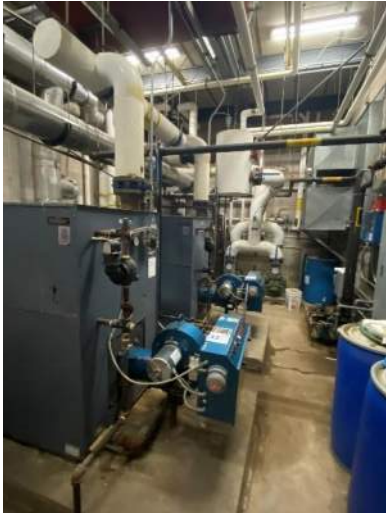
Boilers

1. Heating for the building is generated by two oil fired boilers manufactured by Weil McClain, with 2,000 MBH capacity each. The boilers are 20 years old and nearing their approximately 25 year useful life. Regular maintenance appears to be occurring based on maintenance notes on the units.
2. The boilers are controlled with a Heat-Timer system controller which circulates hot water based on time and outside temperature. Though commonplace in the past, this system does not give the same efficiency of modern systems.
3. Hot water circulation pumps are 7-1/2 HP base mounted constant speed end suction pumps which appear to be regularly maintained. Any changes to the hot water heating plant should include upgrade to newer pumps with variable speed drives for energy efficiency.

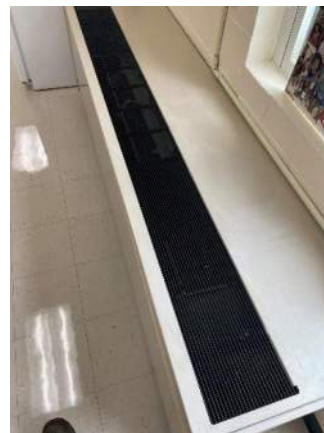
Unit Ventilator

some signs of minor corrosion on the connected piping. Newer units could provide variable speed control and enhanced efficiency for an energy savings.

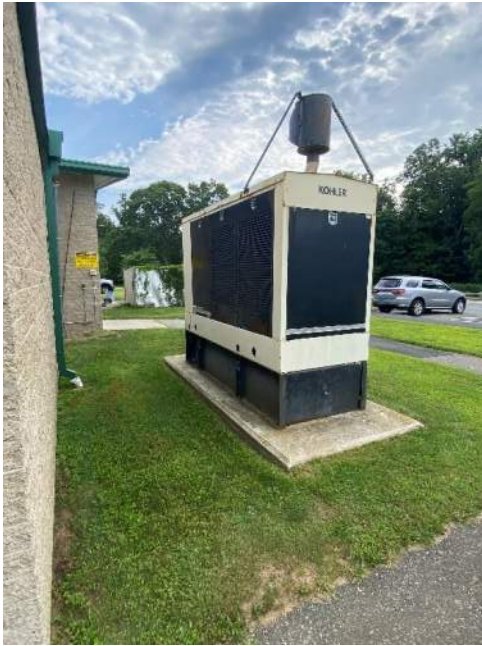
Generator

1. The Main Service Switch and distribution section is rated at 1600A, 120/208V, 3-phase, and is manufactured by Siemens. The main switchgear is approximately 20 years old and is in good condition. All panelboards and conduits within the electrical room appear to be clean, dry, and well labeled. Switchgear which is well maintained has a useful life of 30-50 years or more.
2. The incoming service from the street is stepped down in voltage to 208V by a site mounted 300 kVA exterior transformer owned by the utility company.
3. A 350 kW Kohler diesel generator is located outside the kitchen area and provides backup power for the facility. The generator appears to be 20 years old and in fair condition. Regular testing and service on this generator could lead to a 30 year useful life.

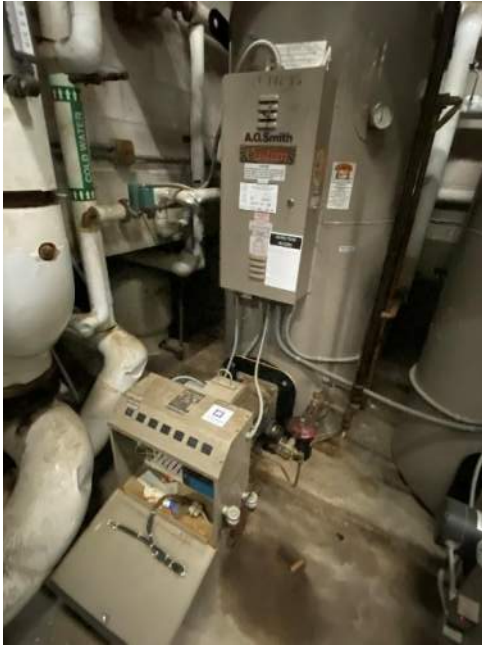
Oil Water Heater

1. There are two oil fired hot water heaters serving the main, located in the mechanical room. Both units are AO Smith brand, model COF-140-720 with 140 gallon storage capacity each. Both units are approximately 20 years old and at the end of their useful life. Water Heater #1 appeared to have undergone service recently.

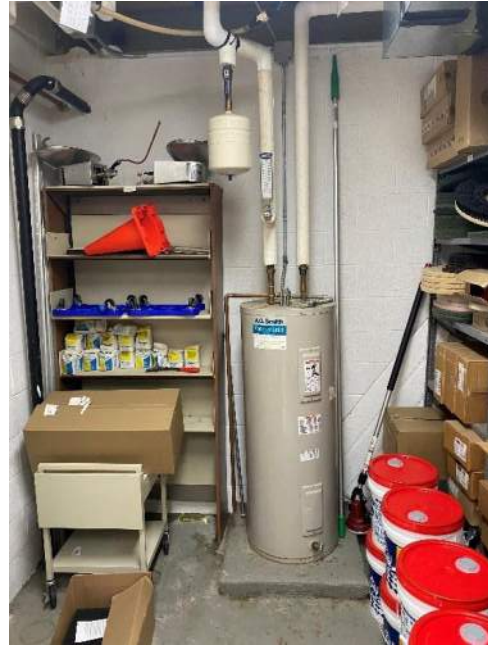
Electric Water Heater

2. An electric water heater is located in the rear of the building near the gym in a storage closet. This unit is an AO Smith model PEC 52 with 50 gallon capacity. The unit is over 20 years old, in fair condition, and beyond its useful life expectancy. This unit appears to only service the gym bathrooms.
3. Two hot water mixing stations exist in the mechanical room. One serves general hot water at 110 degrees, and the other serves kitchen hot water at 140 degrees. Each service is served by a hot water recirculation pump which appear to be in good condition.
